In as comprehensive a work as this, some errors and omissions inevitably occur. There were several instances of this in Volume One. I hope that the following will serve to set the record straight. I should like to thank those readers who have brought some of these items to my attention and thereby keeping me humble!

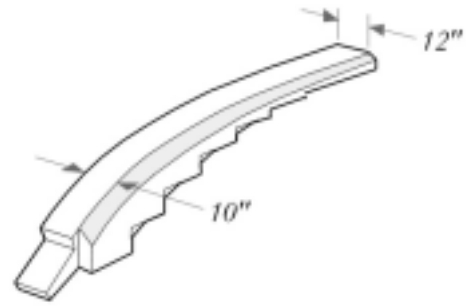
Stage 2

In this section one of the illustrations of the lower apron under construction, *stage 2*, on page 36 was incorrectly drawn. The scarph is shown in the wrong orientation. The corrected illustration is given here. You may wish to Xerox a copy of this and paste it over the incorrect version.

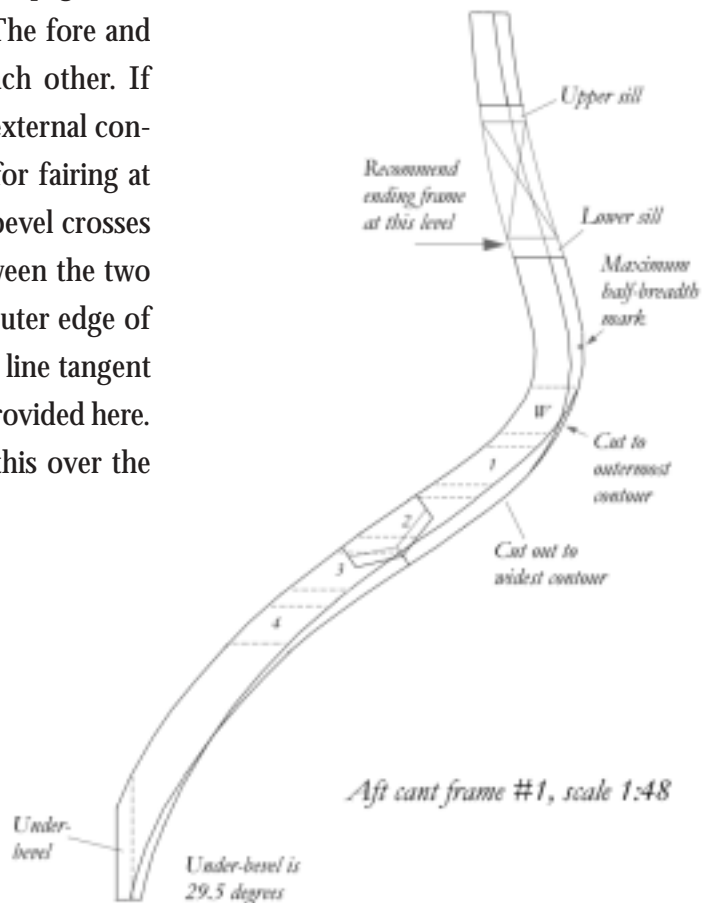
The plan of the aftermost aft cant frame on page 81 is shown in a way that might mislead you. The fore and aft faces are drawn superimposed on each other. If one were to cut out the toptimber to the external contours, there would be insufficient wood for fairing at the level of the wing transom where the bevel crosses over. This is where there is a hollow between the two contours where they curve sharply. The outer edge of the toptimber needs to be cut out along a line tangent to the two curves. A modified drawing is provided here. Again, you may wish to copy and paste this over the original drawing.

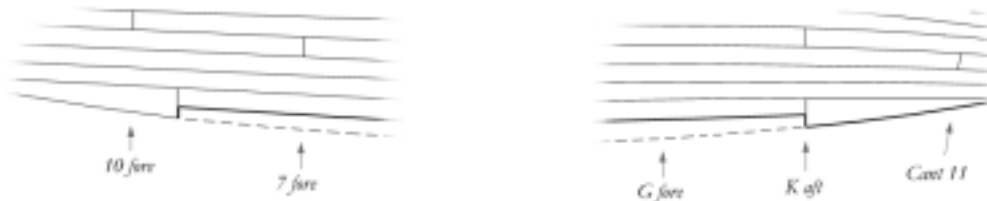
I have had second thoughts about the fore and aftermost limber strake planks. Rather than small triangular filler pieces, the arrangement may have been much simpler. The revised drawings appear below. These illustrations are part of the inboard expansion plan, pages 186 and 187. You may wish to superimpose copies of these drawings on this planking expansion.

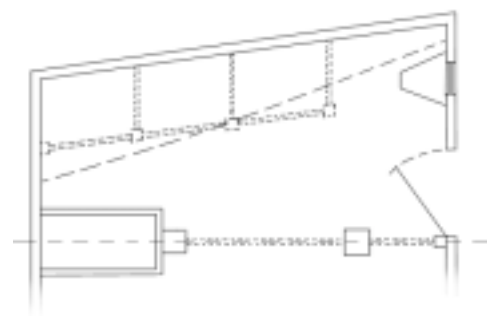
*Part of magazine, scale 1:48
from ZAZ4486*

It appears that the aftermost bank of drawers, shown below, could not have been removed from the racking. The mizen mast bulkhead seems to block them from sliding all the way out. The explanation for this arrangement is that the drawers were shallower than those in the fore two racks. The ship’s side slopes inward behind the drawers, limiting their depth. The layout on this draught is shown here for completeness’ sake. You may interpret this drawing as you wish.

The hatched lines drawn along the centerline between the pillars are problematic: perhaps they delineate the division between magazine and filling areas. There is no indication of a doorway here, so this may simply be a low partition (like the manger) fitted between the pillars to help contain the powder barrels. If you choose to show this, the planks should be removeable and fit into slots created by battens nailed to the stanchions.

Since publication of Volume One, I have seen a copy of the lower deck and platform plans for *Atalanta* (ZAZ4486). These represent the “as designed” rather than “as built” drawings, but they do indicate the disposition of the cartridge racks in addition to the pillars and some stanchions.

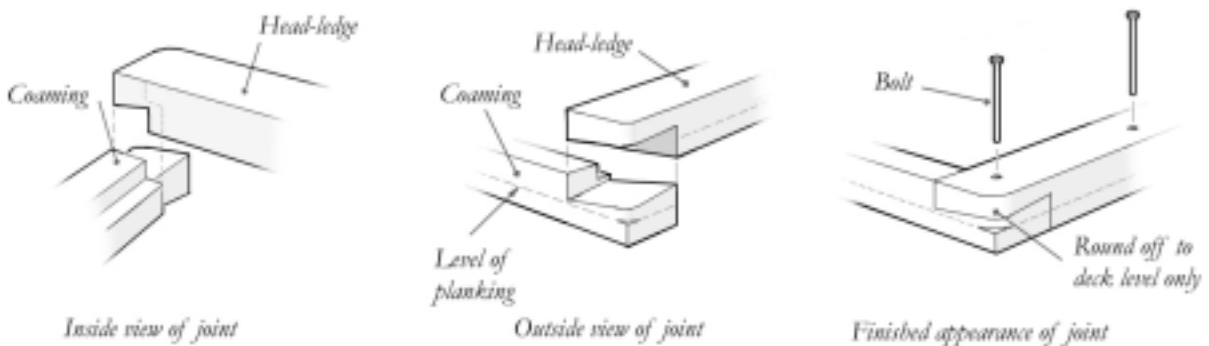
Based on contemporary model evidence and my own experiments, I would like to present an alternative reading of Steel's ambiguous description of their construction. It is more logical if the head ledges "trap" the coamings when they are bolted to the beams. The joint locks in such a way as to prevent the corners being drawn apart. As shown (*below*), the relationship of the joint surfaces is the reverse of my previous interpretation. Please replace the previous illustrations on page 272 with those given here.
